CONNECTICUT RIVER BASIN  
HANOVER, NEW HAMPSHIRE

HANOVER CENTER RESERVOIR DAM  
NH 00051

PHASE I INSPECTION REPORT  
NATIONAL DAM INSPECTION PROGRAM

APRIL 1979

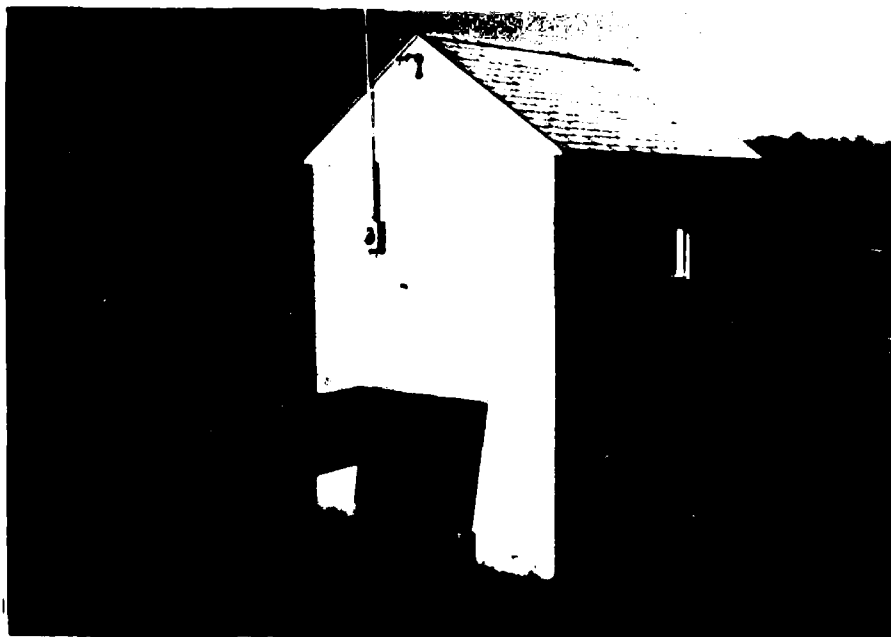
(2) Water Supply Valve Structure. A 10-foot square concrete structure that supports the valvehouse (See Appendix C - Figure 6) is located approximately 80 feet from the north end of the dam on the upstream face. The valves control flow into the Town of Hanover water supply system. The concrete structure was observed to be in good condition.

Figure 6 - Looking at gatehouse which contains valve for controlling discharge into water supply line and fish pond.
